# **OPAL TOWER INVESTIGATION FINAL REPORT**

**Independent Advice to  
NSW Minister for Planning and Housing**

**19 February 2019**

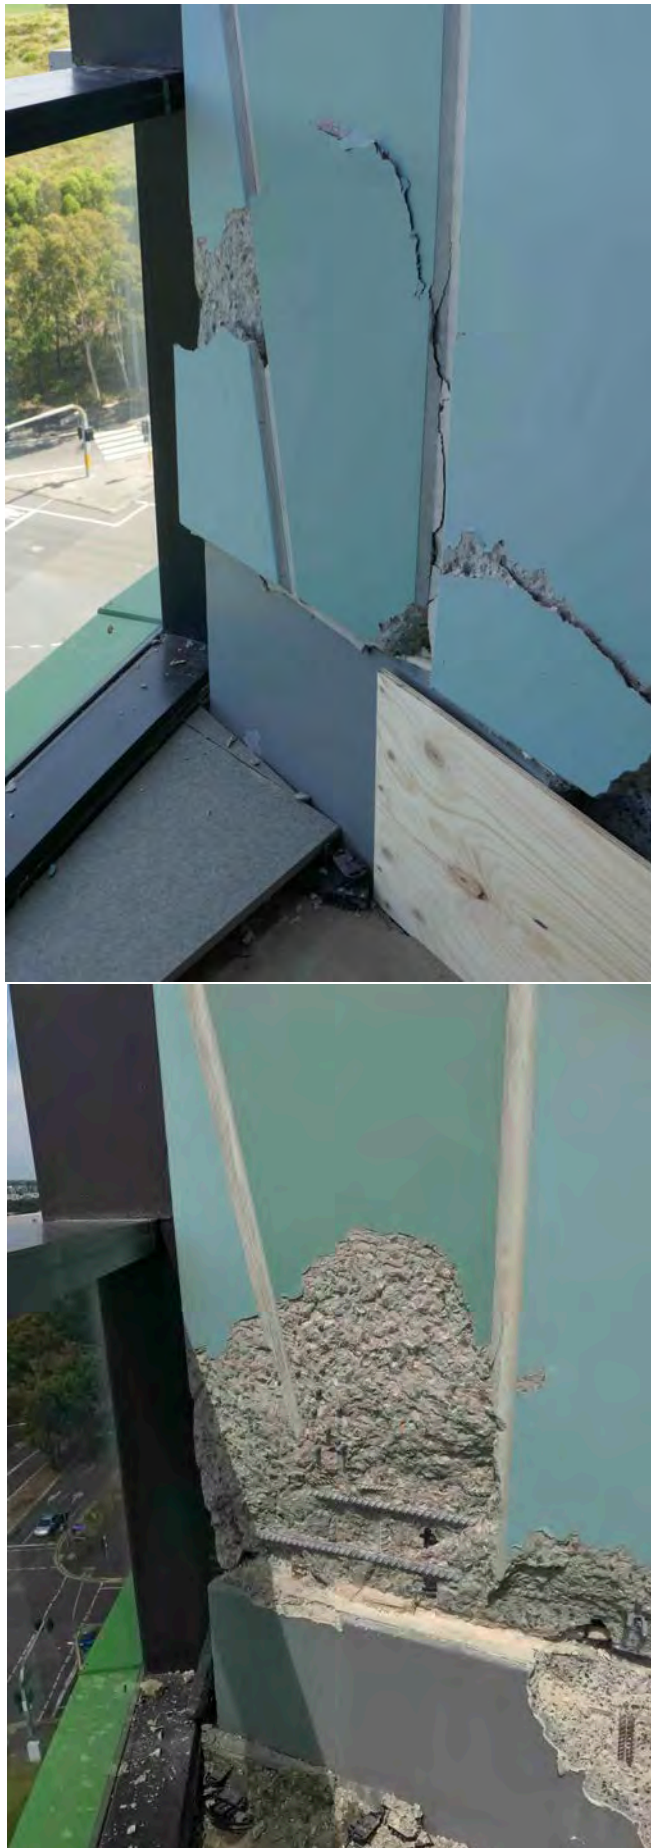
1. A hob beam spanning between columns C21 and C38 (along grid line C shown in Figure 4) and the Panel A resting on it – see Figures 5 to 8. Cracking was also observed in the floor plate adjacent to column C21 – see Figure 9. This was the damage observed on Christmas Eve and is considered to be major damage.

Figure 5. Damaged precast Panel A at Level 10 above column C21, before (top) and after (bottom) broken section of concrete removed.

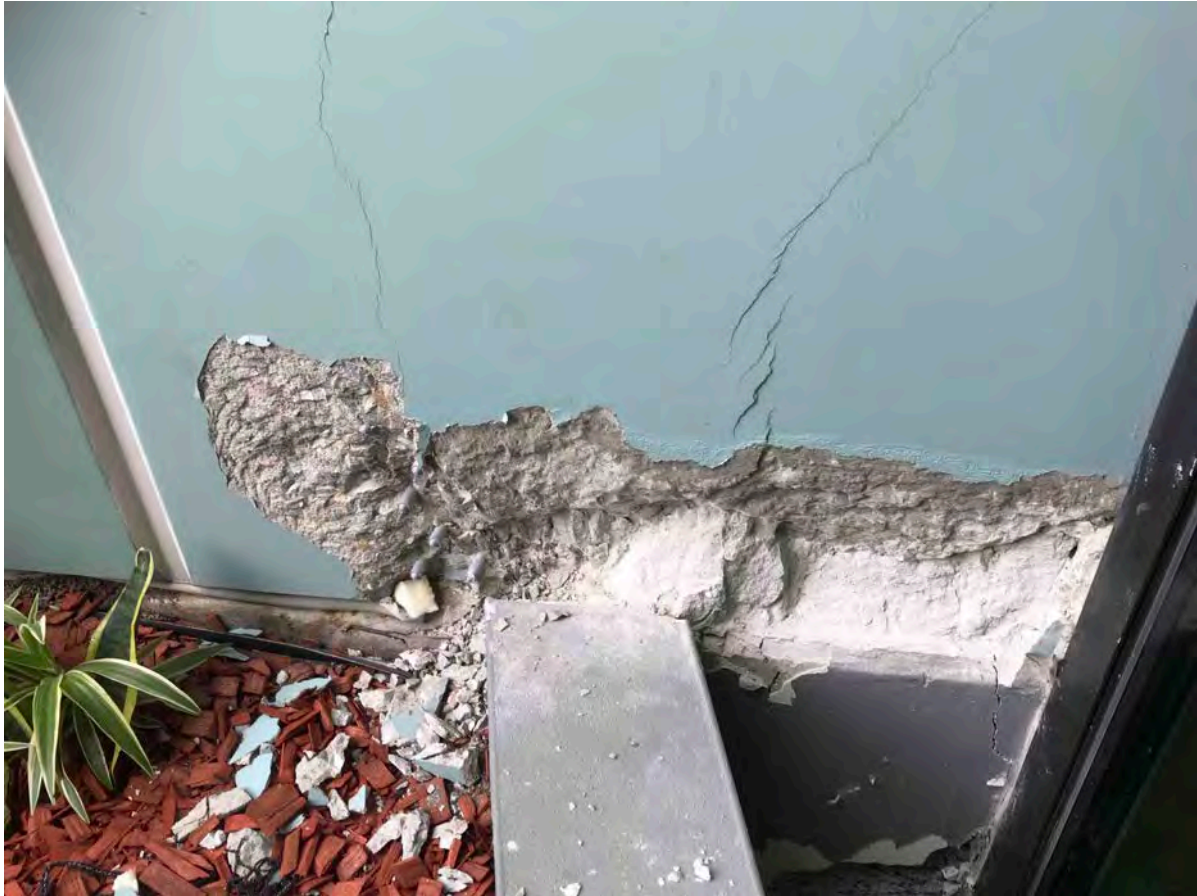
Figure 6. Damaged precast Panel A at Level 10 above column C38, after some broken sections of concrete removed.

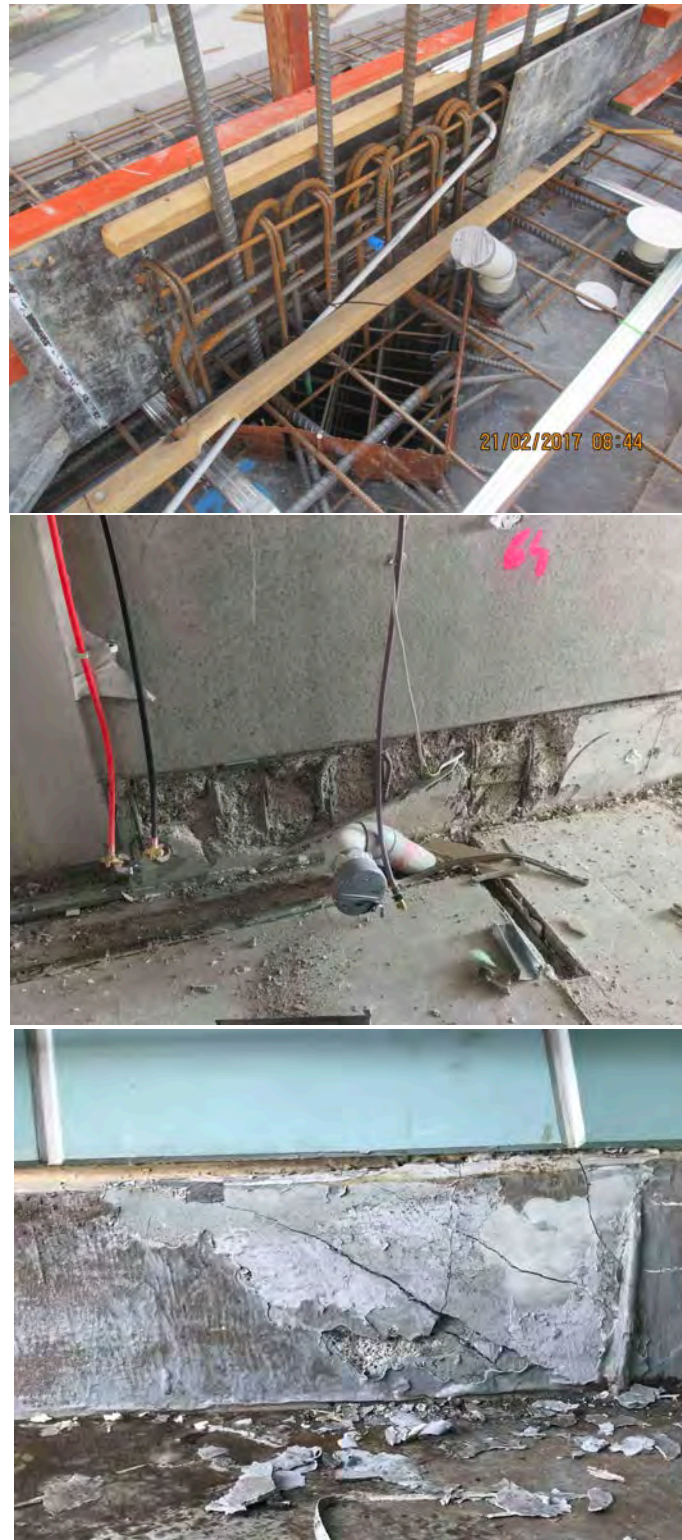
Figure 7. Photographs of the hob beam in the vicinity of column 38 at level 10, prior to pouring concrete (top photo), inside the building on 8 January 2019 after cracked concrete cover removed (middle), and outside on 8 January 2019 after the garden and waterproof covering removed (bottom). Note the positioning of the reinforcing bars, the encroachment of the column bars into the cover zone, the lack of anchorage of some horizontal bars, and the encroachment of a conduit into the concrete cover zone. The vertical dowel bars that engage with the precast concrete panels can also be seen in the top photograph.

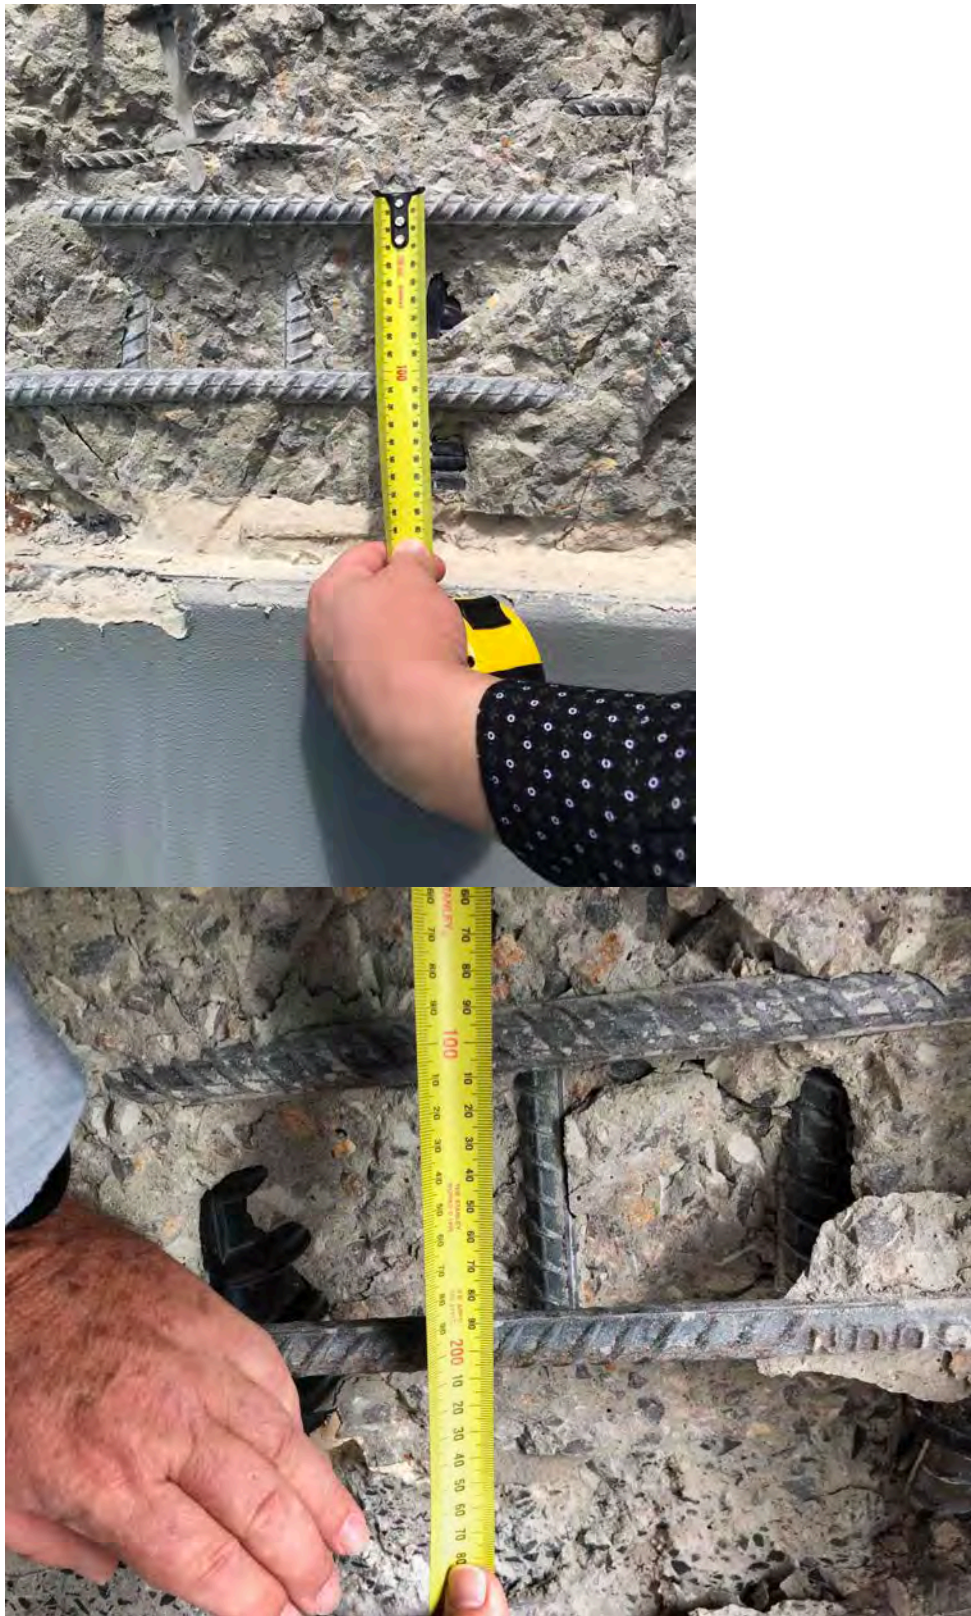
- (e) Potentially inadequate tensile capacity in the horizontal direction in the bottom region of Panel A on that rests on the hob beam spanning columns C21 and C38 on Level 10. There is compelling evidence indicating that the wrong size reinforcing bars were placed in this area during manufacture of this particular

- panel – 20 mm diameter bars were used instead of 28 mm diameter bars (see Figure 8); and
- (f) We could find no evidence, during our site inspections and in the construction photos and photographs of damaged hobs, that reinforcement cross-ties were incorporated in those hobs to resist bursting forces.

Figure 8. Photographs of the outside (top) and inside (bottom) of panel A at Level 10 just above hob beam adjacent to column 21, indicating N20 reinforcing bars at 100 mm centres in the lower portion of the precast panel. Note the exposed grout between panel A and the hob beam and the black plastic sheath for the joining dowel (top photo, right of tape measure).

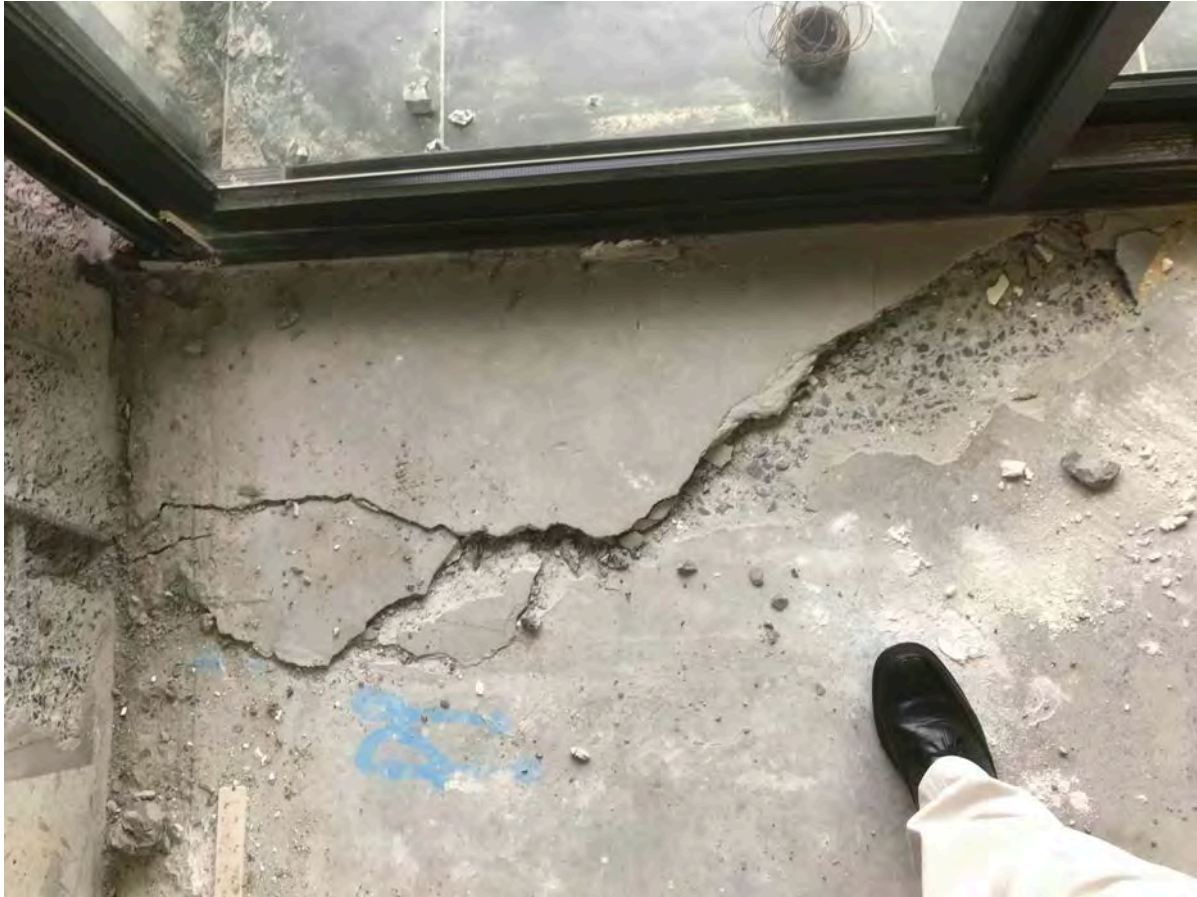
Figure 9. Photographs of the damaged floor slab adjacent to column C21 on Level 10.

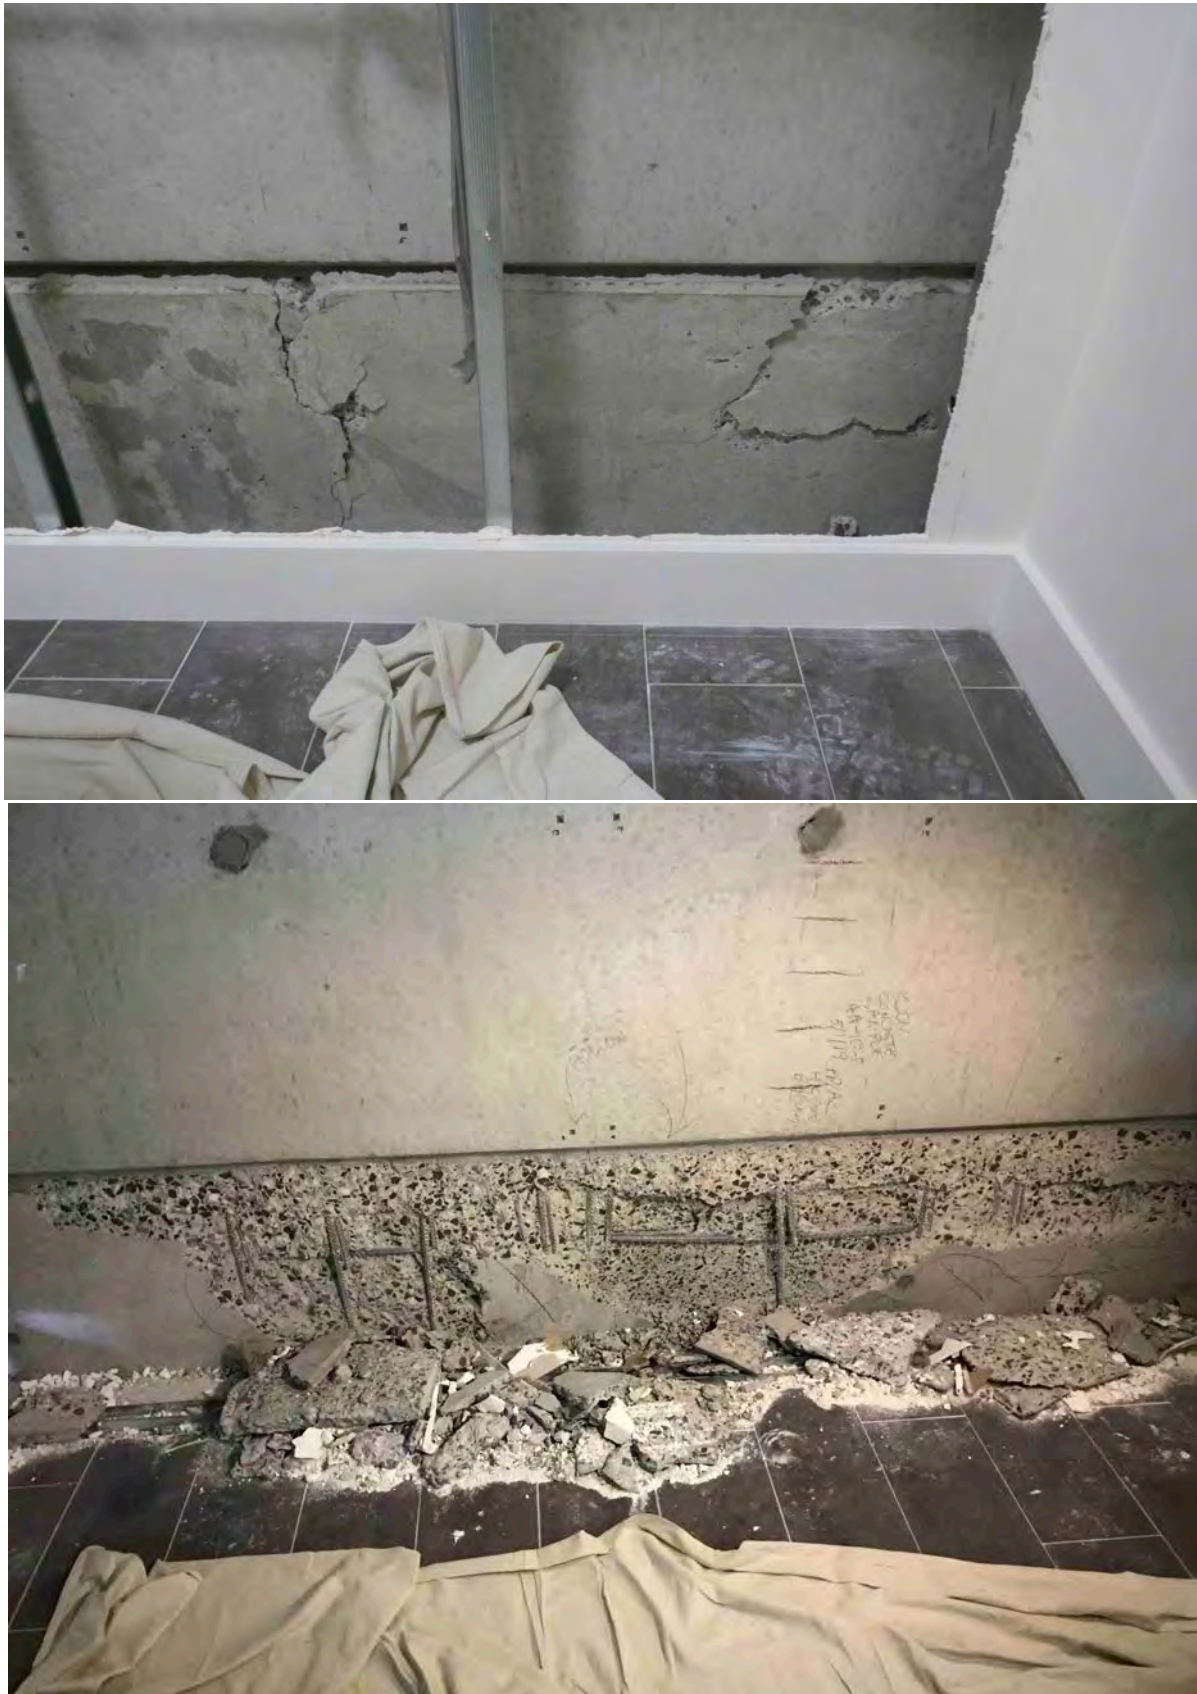
2. A hob beam spanning between columns C16 and C34 (along grid line A shown in Figure 3) – see Figure 10. This also appears to be major damage.
3. A hob beam spanning between columns C2 and C22 (along grid line B shown in Figure 3). These cracks could be considered minor *at this stage* – see Figure 11.
4. Cracking was also observed in the floor plate between Levels 3 and 4 – see Figure 12. This was considered to be major damage.

Figure 10. Photographs of the damaged hob beam on Level 4 near column C34 before (top) and after (bottom) cracked concrete removed.

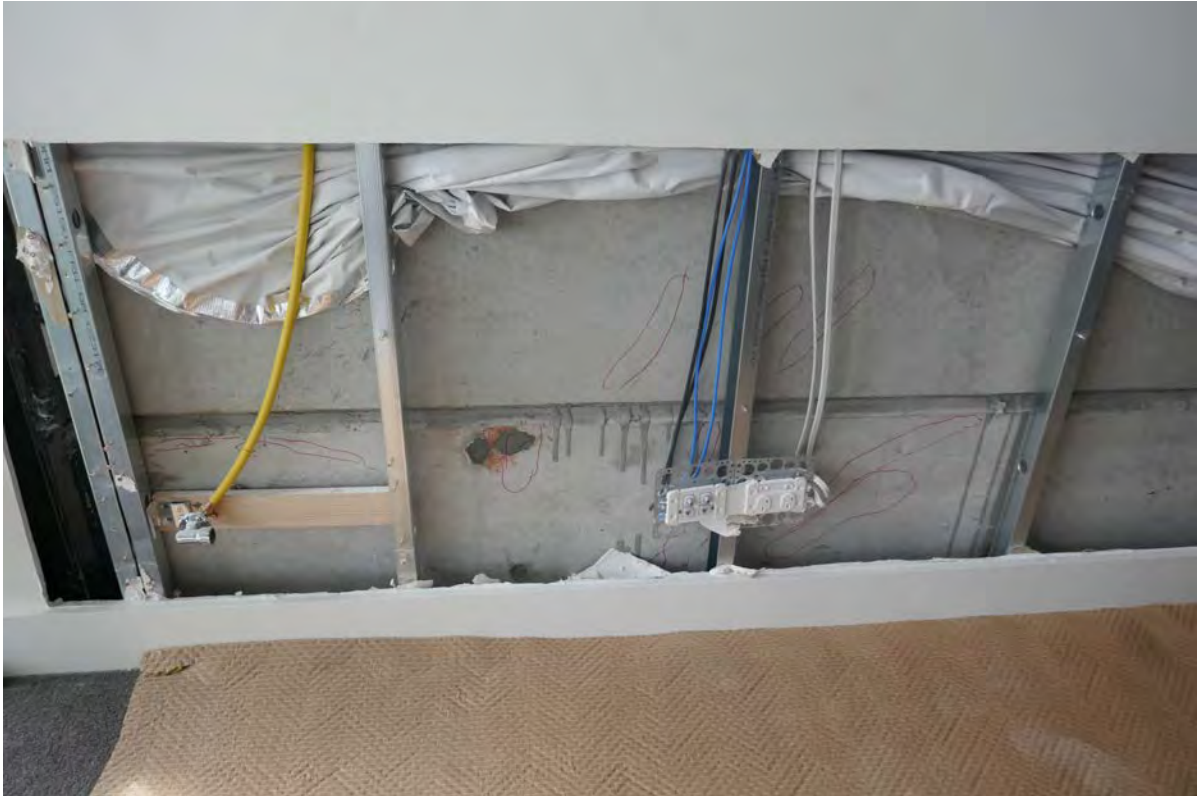
Figure 11. Photograph of the hob beam and panel on Level 4 near column C2 with red lines indicating minor cracking.

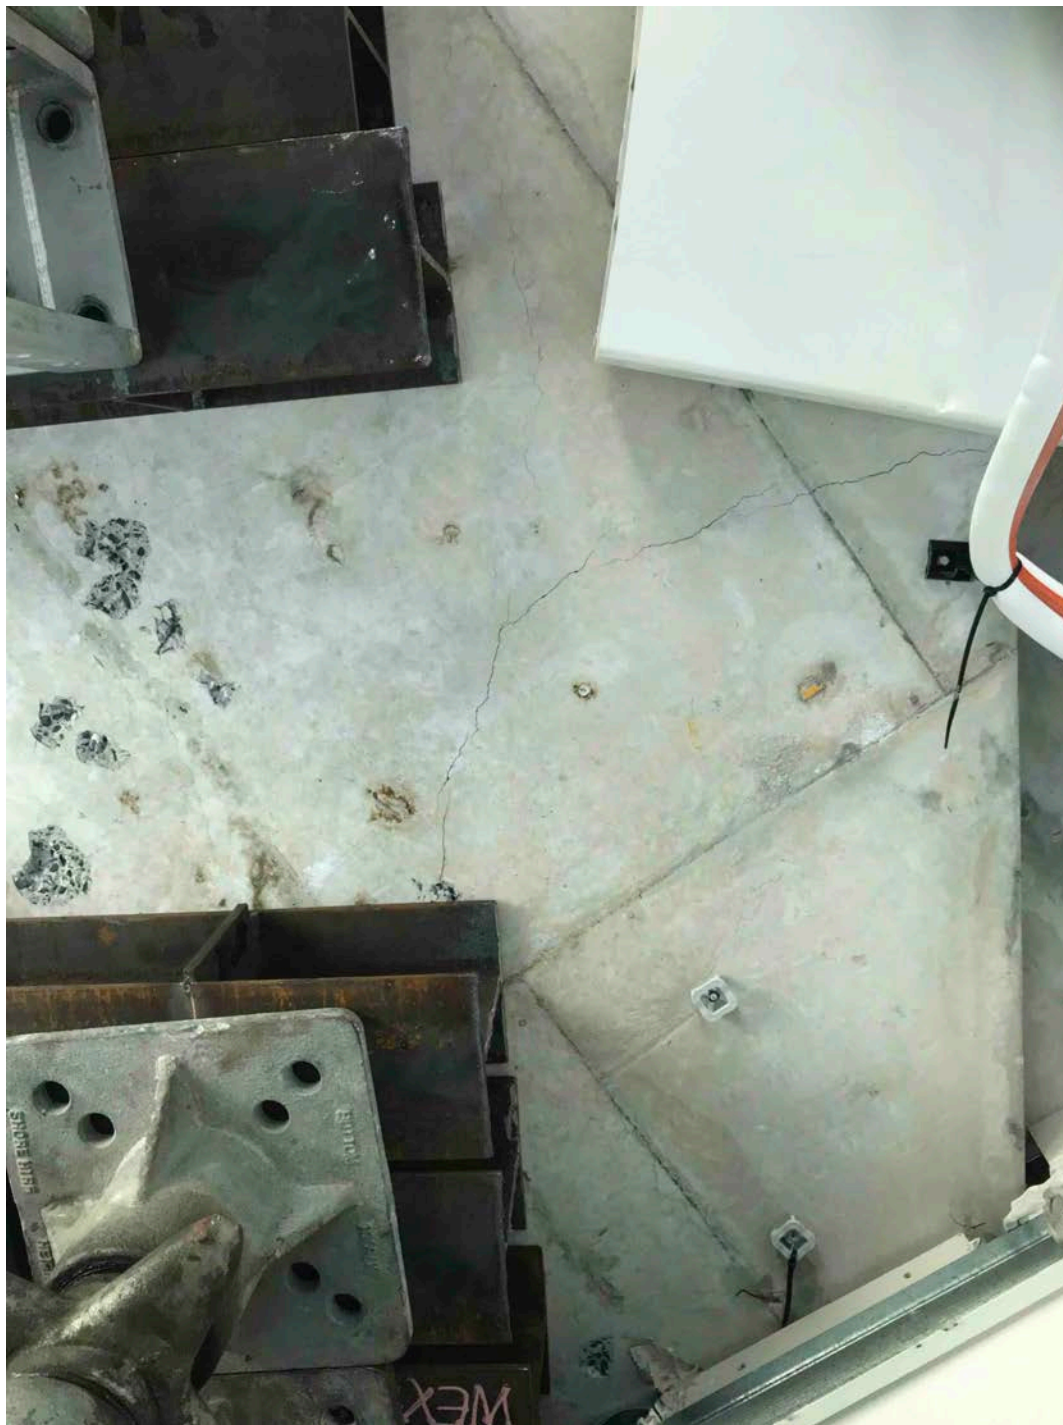
Figure 12. Photograph of a crack in the floor plate between Levels 3 and 4.

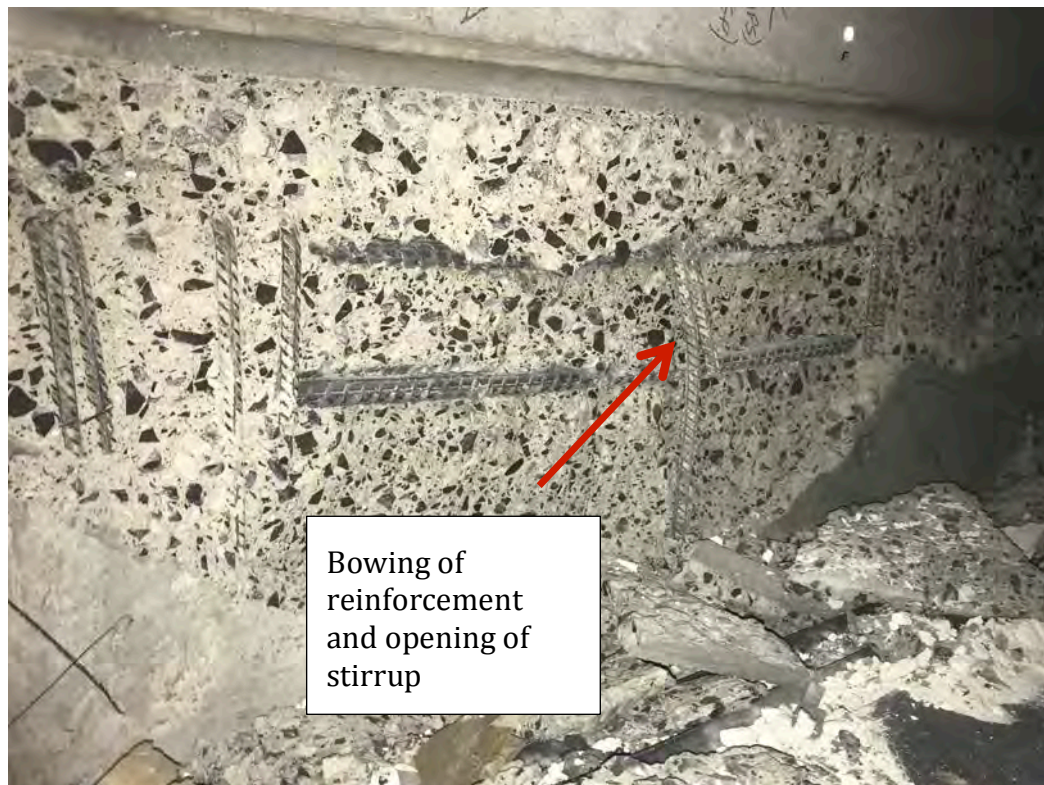
The damage observed in the hob beam above Column C34 at Level 4 is shown in Figure 15. This image indicates bowing of the reinforcement steel outwards from the beam and opening of the stirrup. Also noticeable is a lack of cross-tie reinforcement to guard against splitting failure..

The site observations of the damaged beam are consistent with a bursting failure.

Figure 15. Damage in hob beam at Level 4 above column C34 showing bowing of reinforcement and opening of stirrup.

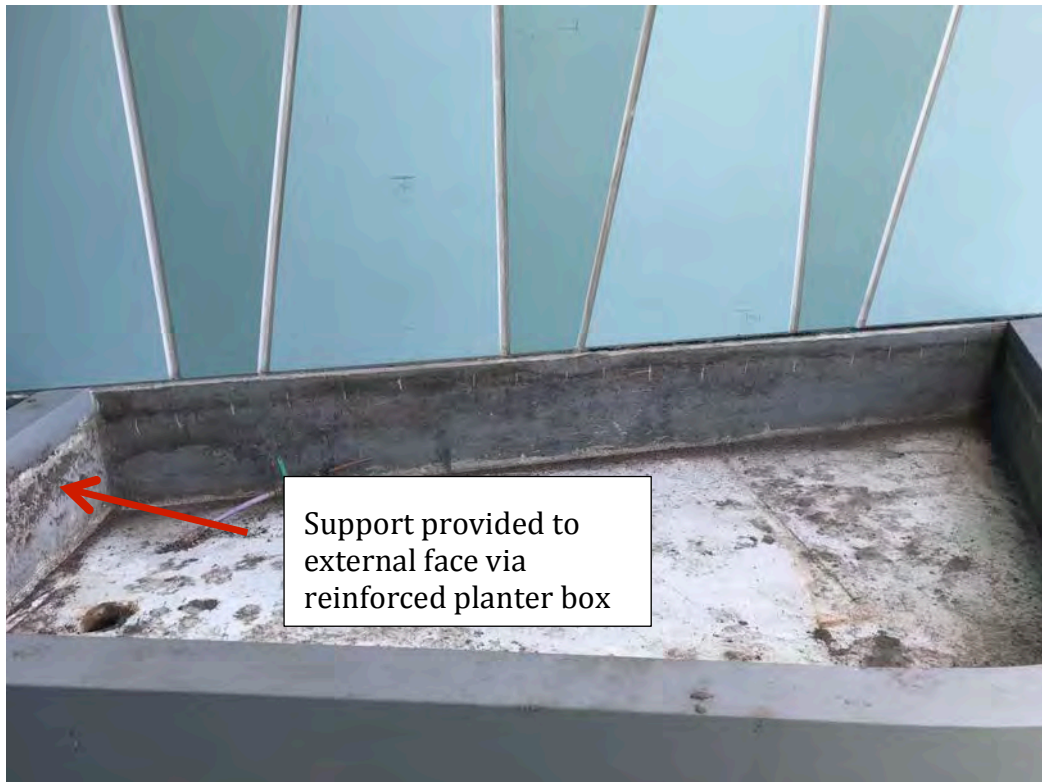
It is notable that the observed damage was constrained to the inside facing of the hob beam; the outside of the hob beam at the critical section was supported by a lateral garden bed wall (Figure 16) built integrally with the slab and against the hob beam. This wall likely provided support to the outer side of the hob beam forcing the damage inward where such support was lacking. This damage remained “hidden” until exposed on 27 December 2018 after removal of an internal wall in the adjacent apartment. It is not known when this damage occurred.

Figure 16. Lateral support provided to hob-beams at outside elevation through reinforced planter box hob – Level 4 Grid Line A.

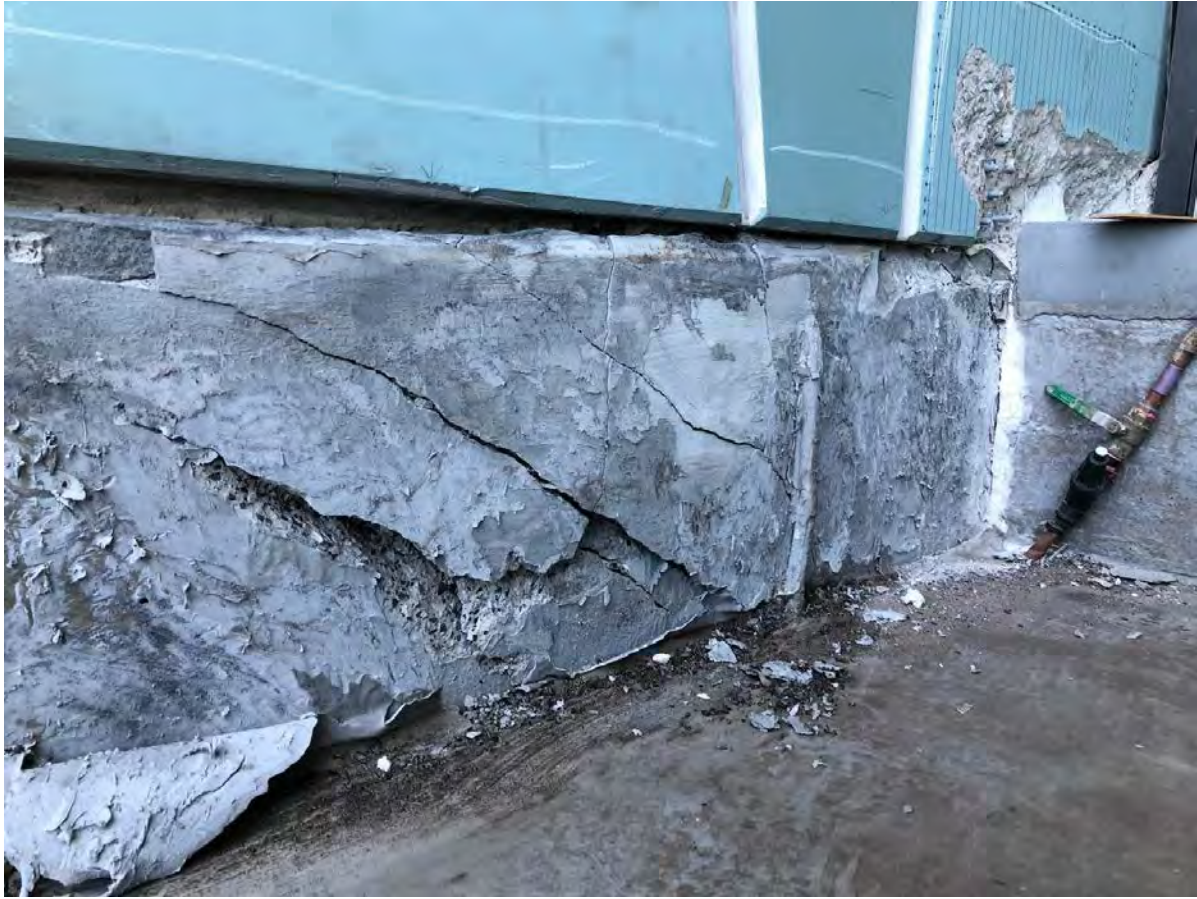
The damage in the hob-beam above Columns C21 and 38 at Level 10 is shown in Figures 17 to 20. For the hob-beam above column C38, Figure 17 shows splitting along the lines of shear compression, indicating high levels of stress on each of the in-plane and out-of-plane surfaces. While bursting appears to be the dominant mode of failure, bearing stresses appear to have also been influential in forming the failure surfaces.

Figure 17. Hob beam at Level 10 in the vicinity of column C34 (outside) showing splitting along shear compression crack band lines.

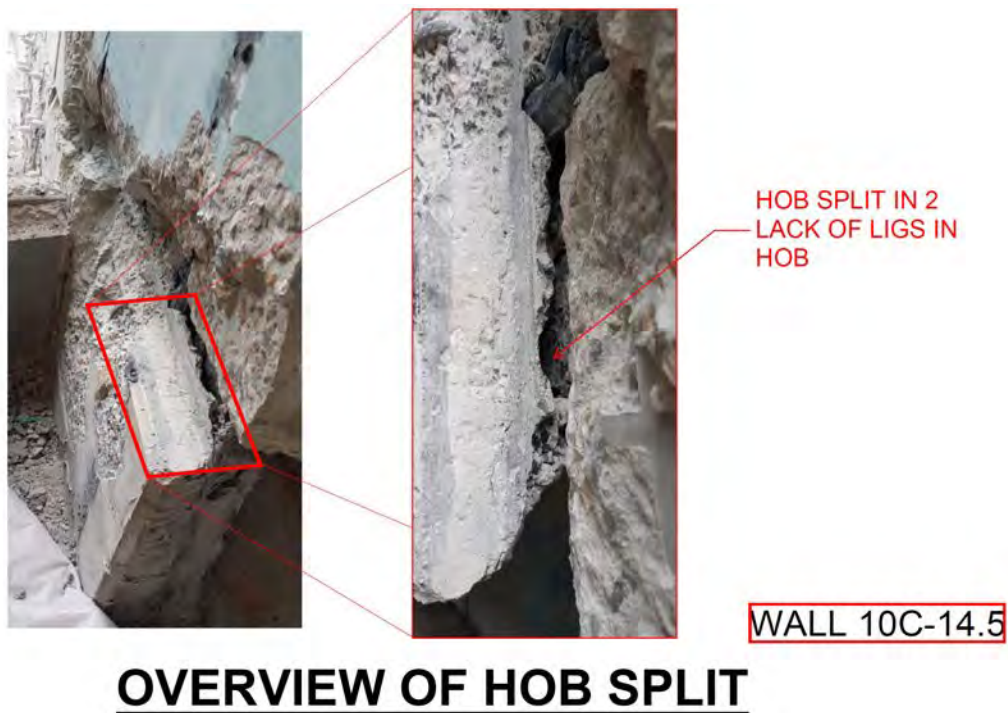
Figure 18 shows observations presented to us of the hob beam above Column C38 when the walling was opened. These images reveal evidence of splitting along the hob centreline. A crack, running the length of the hob beam between the supporting columns, was also observed at the soffit of the Level 10 floor slab (Figure 19). Splitting of the hob and wall panel is also evident in Figure 20.

Figure 18. Photographs at Wall 10C-14.5 (Level 10 grid line C) documenting a splitting crack in the hob beam.

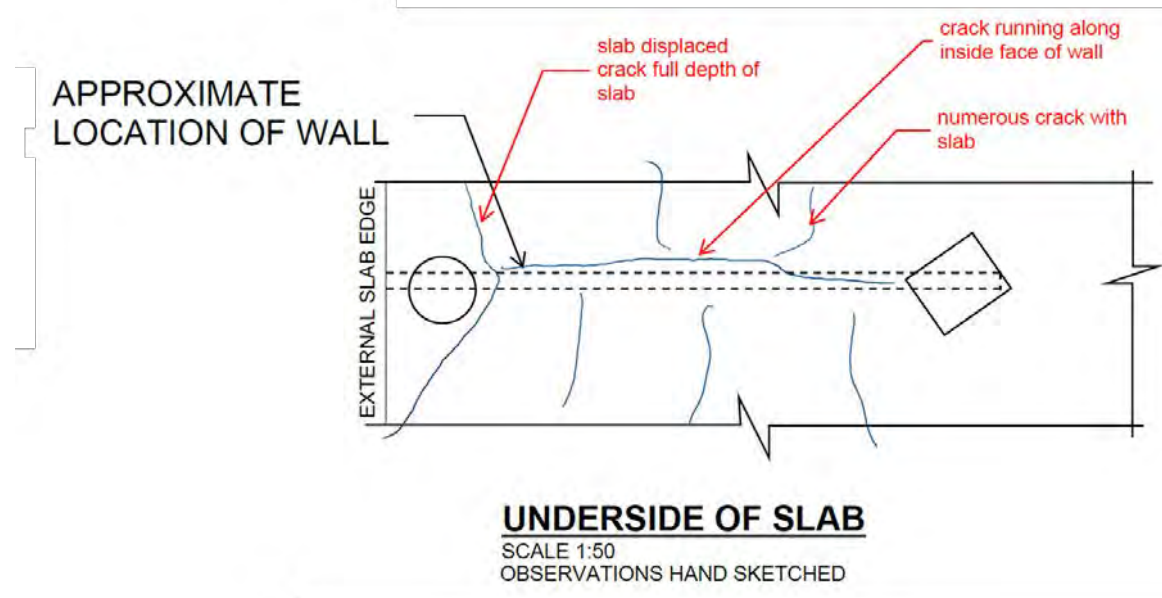
Figure 19. Drawing of the underside of Wall 10C-14.5 (Level 10 grid line C) documenting a splitting crack in the floor slab between columns C21 and at C38.

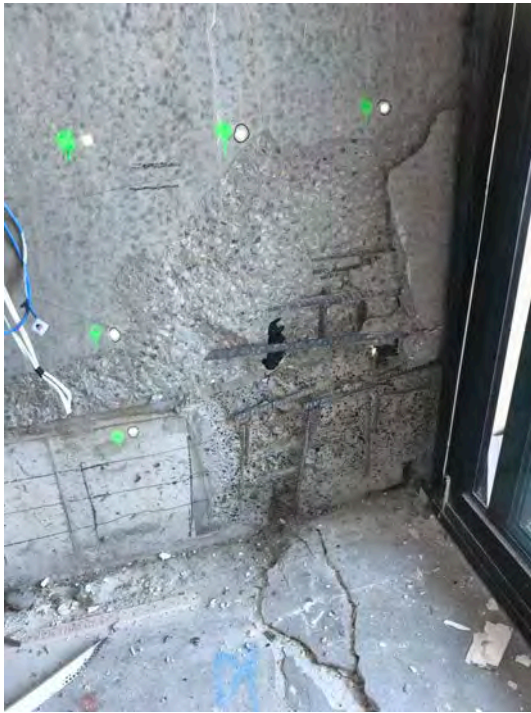
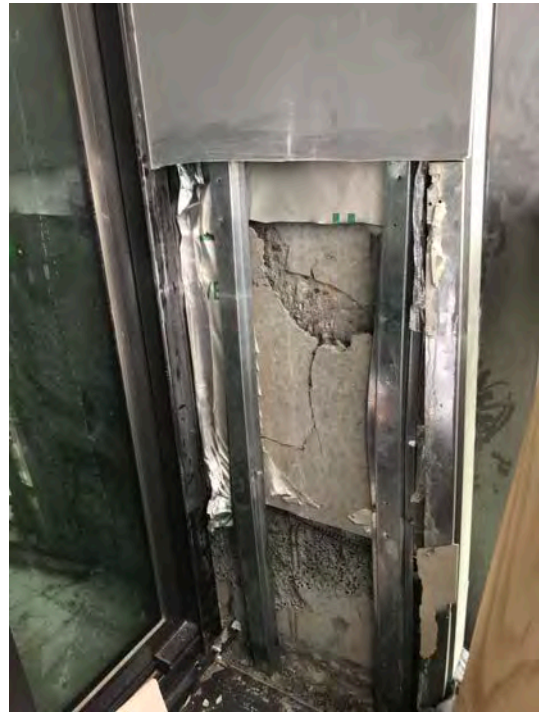
These observations are consistent with our calculations that indicate a lack of capacity of the hob against bursting. As for Level 4, no cross-tie reinforcement is evident in the hob-beam at either location where spalling or crushing occurred.

Figure 20. Hob-beam and precast wall panel at Level 10 in the vicinity of column C21 (apartment side) showing splitting of the precast panel and the damaged hob beam.
