# **OPAL TOWER INVESTIGATION FINAL REPORT**

**Independent Advice to  
NSW Minister for Planning and Housing**

**19 February 2019**

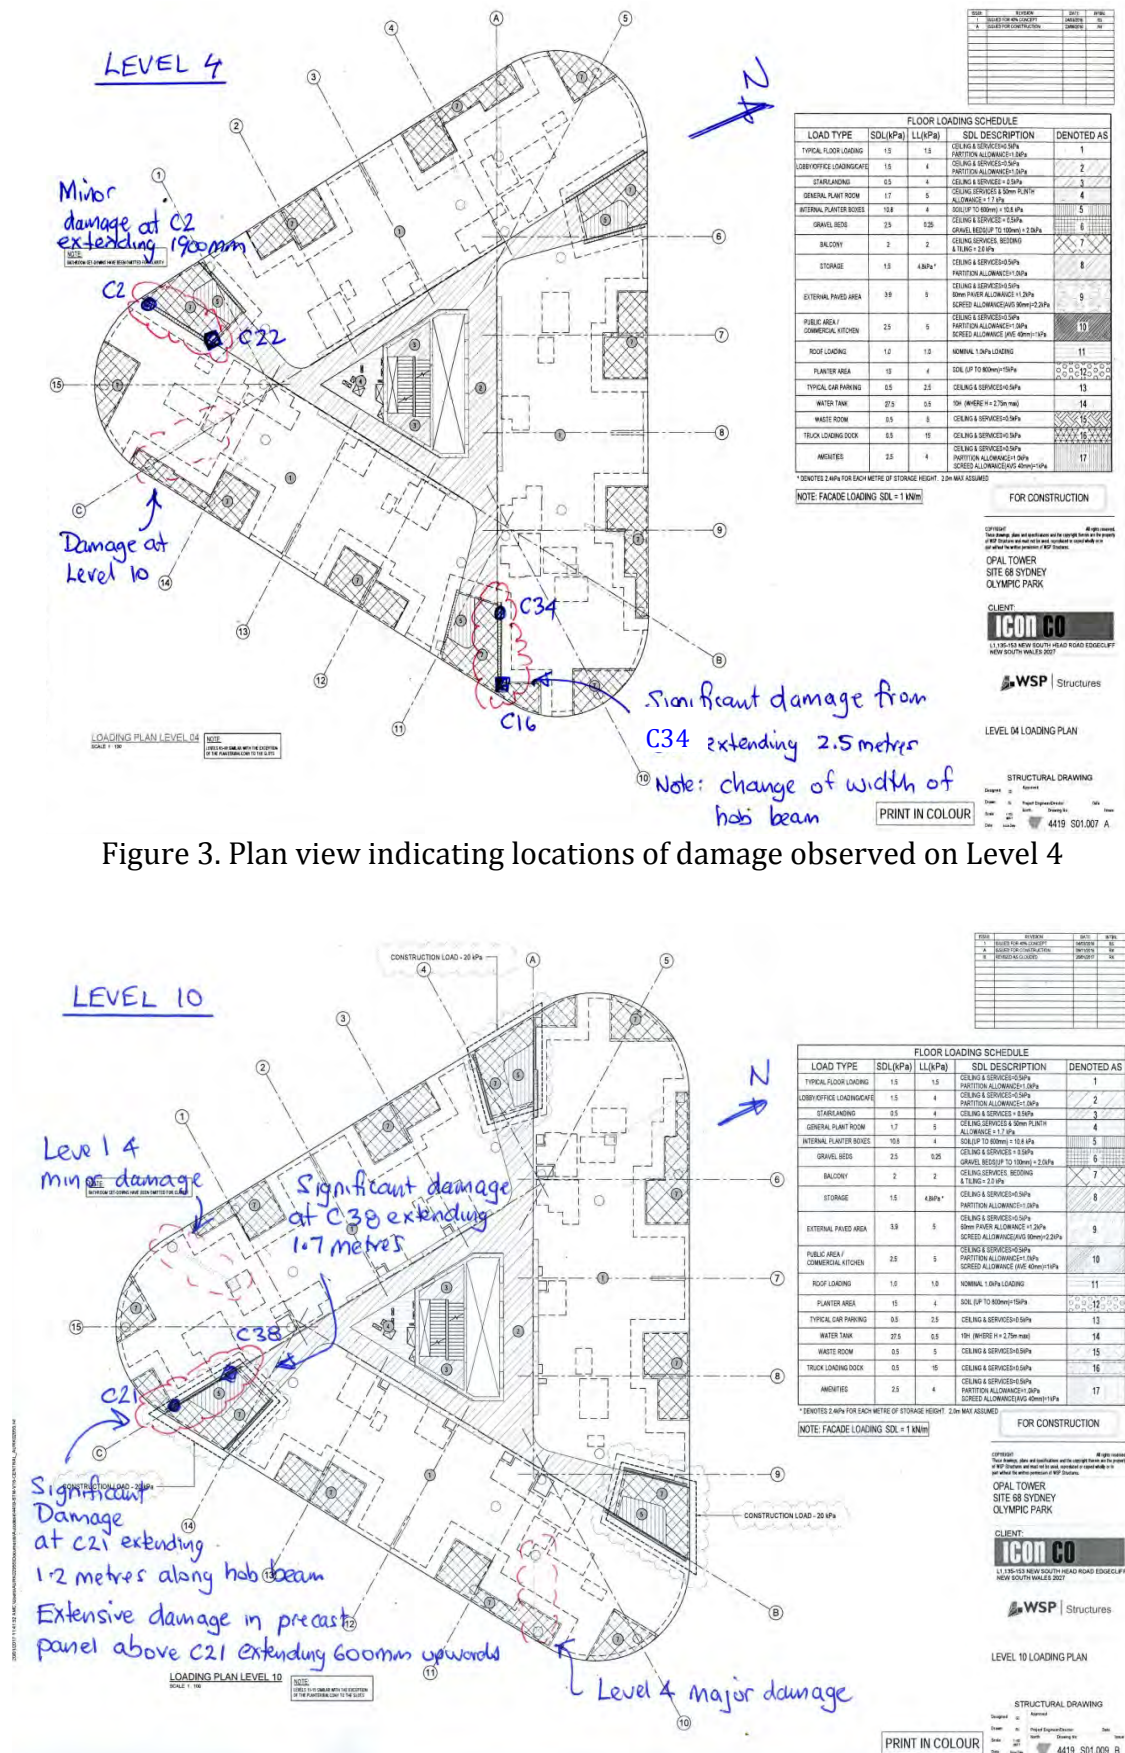
The areas of significant structural damage are located on Levels 4 and 10 of the Opal Tower. The approximate locations of these damaged regions are shown in Figures 3 and 4.

2. A hob beam spanning between columns C16 and C34 (along grid line A shown in Figure 3) – see Figure 10. This also appears to be major damage.
3. A hob beam spanning between columns C2 and C22 (along grid line B shown in Figure 3). These cracks could be considered minor *at this stage* – see Figure 11.
4. Cracking was also observed in the floor plate between Levels 3 and 4 – see Figure 12. This was considered to be major damage.

Figure 3. Plan view indicating locations of damage observed on Level 4

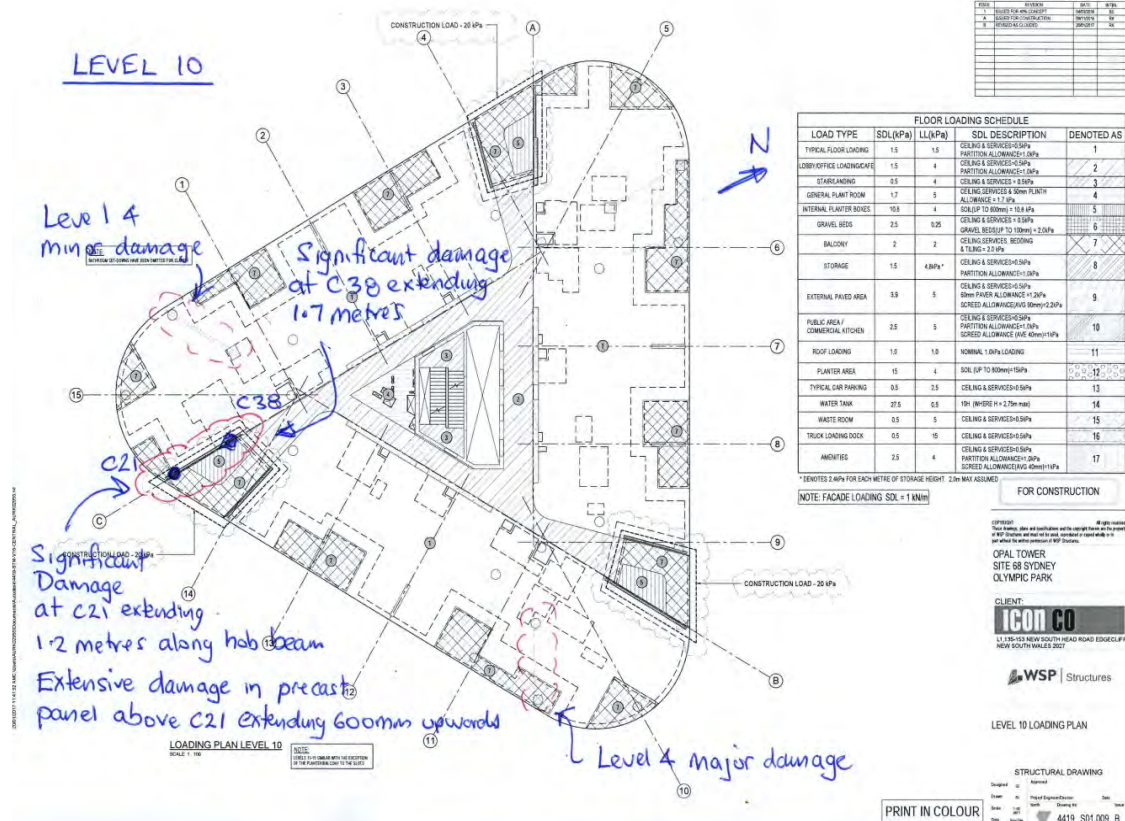
1. A hob beam spanning between columns C21 and C38 (along grid line C shown in Figure 4) and the Panel A resting on it – see Figures 5 to 8. Cracking was also observed in the floor plate adjacent to column C21 – see Figure 9. This was the damage observed on Christmas Eve and is considered to be major damage.

Figure 4. Plan view indicating locations of damage observed on Level 10

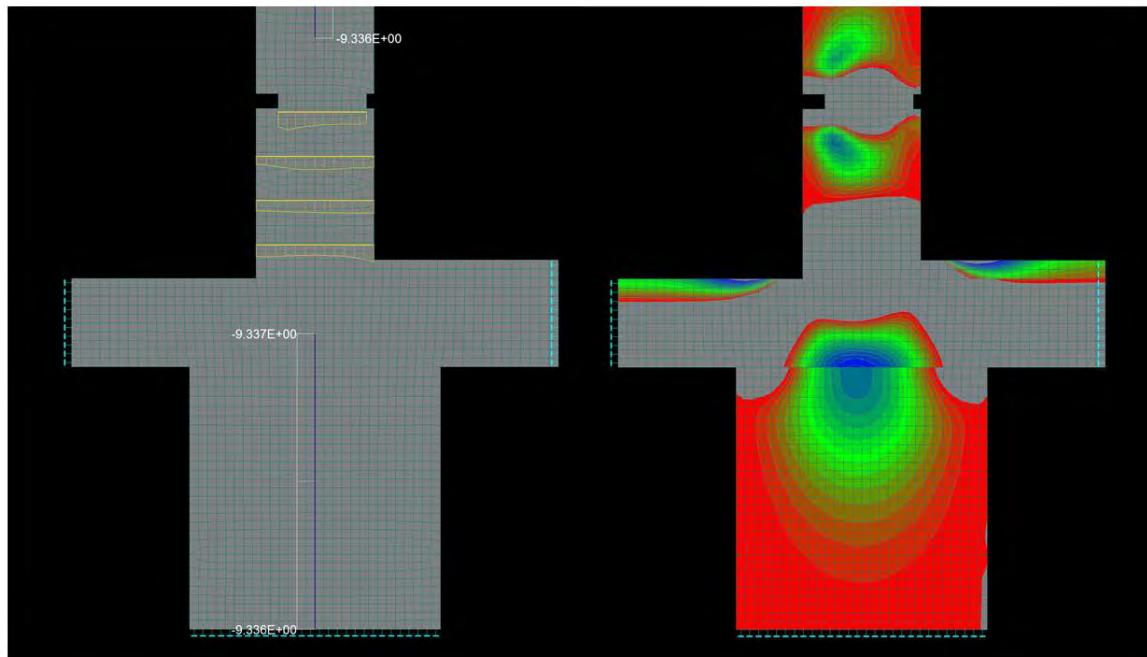
The finite element study investigated specifically the load-deflection behaviour (up to failure) of column C34 at the level of the soffit of the Level 4 floor slab, as well as the stresses and strains induced in the concrete in the column, floor slab, hob and precast panel. Typical numerical predictions of the stresses in the transverse plane are shown in Figure 13 and a possible strut-and-tie model to describe the load path through the connection is shown in Figure 14. Such predictions were made to assess the performance of these structural elements and to observe the predicted mode of

The finite element analysis (Figure 13), albeit preliminary, indicated significant splitting forces in the column adjacent to the hob beam. It would be prudent to undertake a more detailed analysis of this feature and to confirm if appropriate bursting reinforcement is in place. Rectification works may be necessary pending the outcome of the abovementioned detailed analysis.

Figure 13. Typical distributions of axial stresses acting on the hob-beam (left) and tensile bursting stresses (right) – Level 4 Grid Line A.

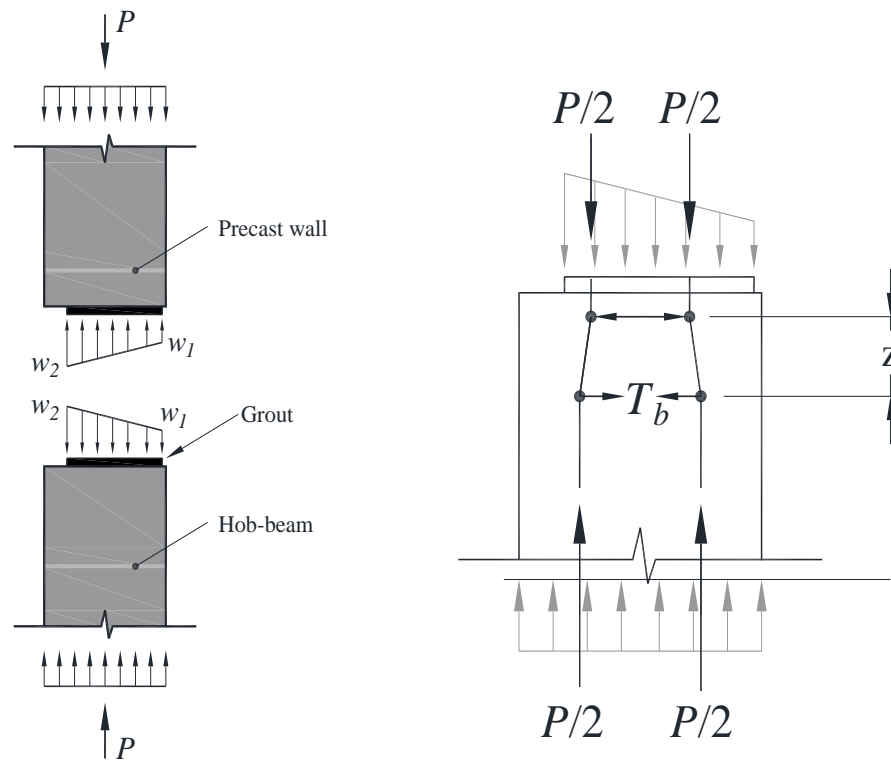
The hand calculations considered the capability of the hob in both bearing and bursting. The axial forces passing through the pre-cast wall panel to the hob beam connection, and then into the columns, were addressed. Some of these calculations adopted the ‘strut and tie model’ describing equilibrium of forces in the hob beam (Figure 14). This hand calculation method followed the approach specified in AS3600.

Figure 14. Schematic representation of axial forces and stresses passing through the wall panel to hob-beam grouted connection (left), and strut-and-tie model describing bursting forces that result from the disturbance caused by the joint's geometry (right).
